## Central Coastal Management Program Advisory Committee

# Shoalhaven Beaches Asset Management Strategy

October 2021

## Why does Council need a Beach Access Management Strategy?

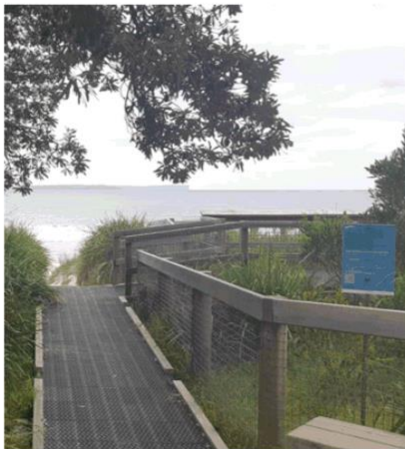
**Collingwood Beach.**

**5 - Excellent, as new.**

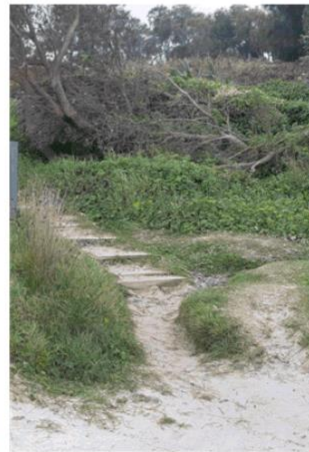
**Berrara Creek**

**4 - Good.**

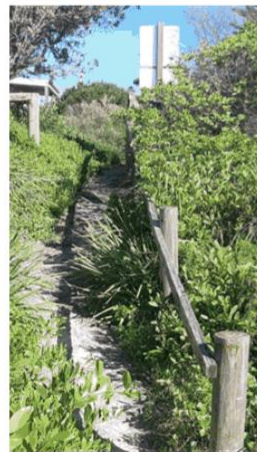
**Mollymook**

**3 - Fair.**

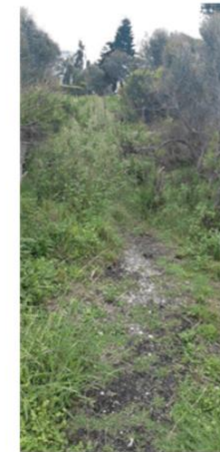
**Gannet Beach**

**2 - Poor.**

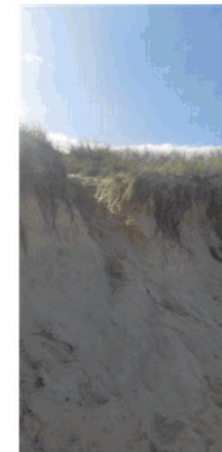
**Burrill Beach, The Spit**

**1 - Failed/Very Poor.**

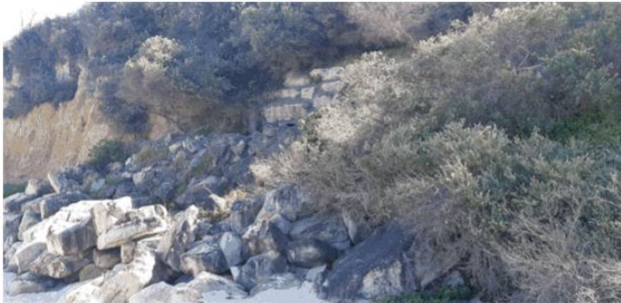
Nelson Beach – slope stability, stormwater outflow

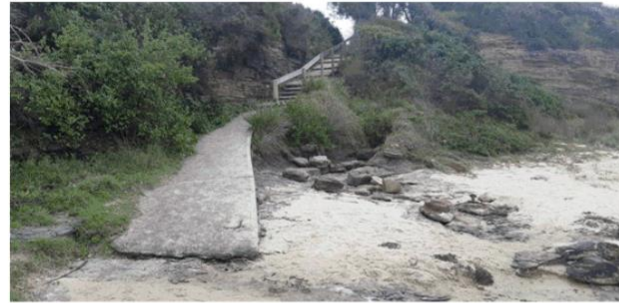
Berrara - Erosion due to runoff

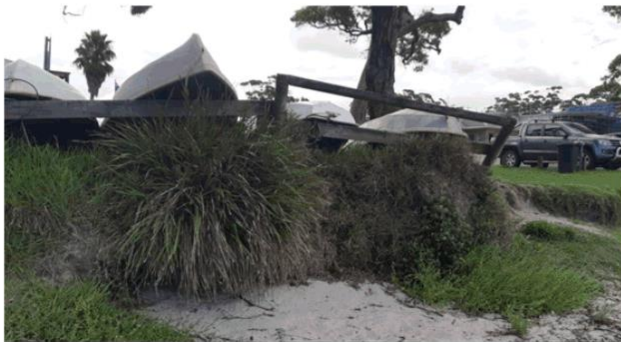
Callala Bay – no formal dinghy storage

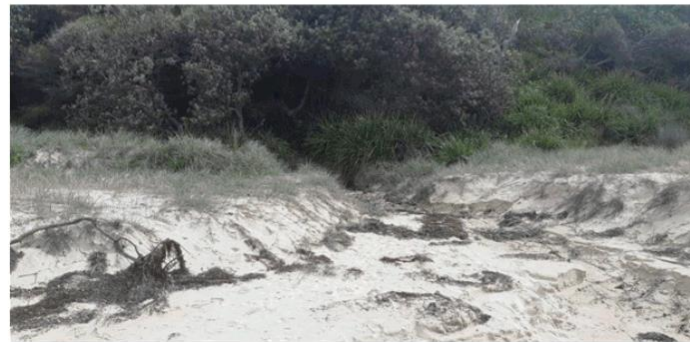
Cunjurong – erosion impacts due to presence of track

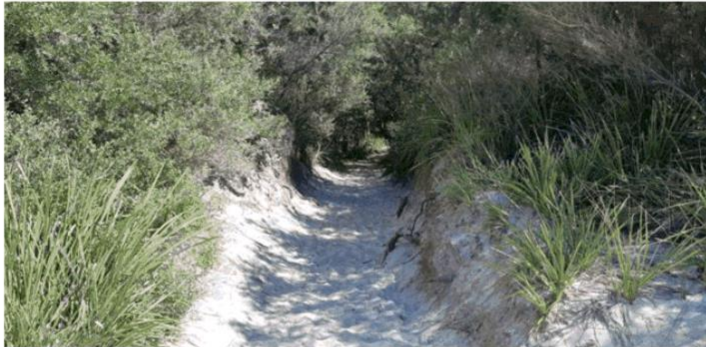
Myola – erosion of dune caused by track

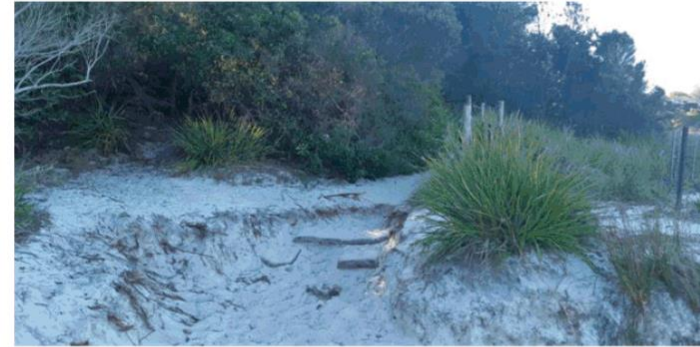
Hyams Beach – erosion of base of walkway

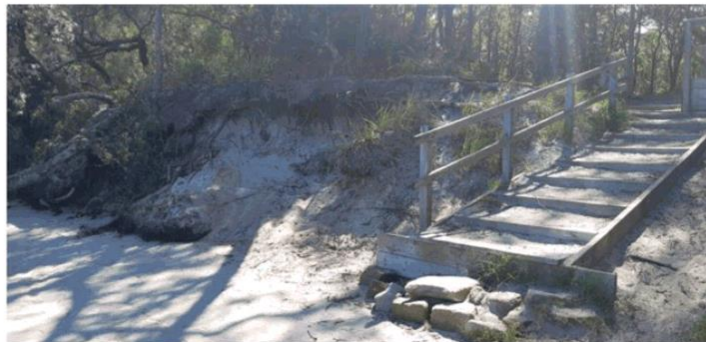
Myola – erosion of creek bank impacting on access

- Investigate the root cause of severe erosion at Currambene Creek and consider mitigation measures (e.g. bank protection, or modification/removal of the old training wall).
- Consider deeper foundations for the stairway at its current location, or moving the main foreshore access close to the root of the existing breakwater where bank erosion is less severe.

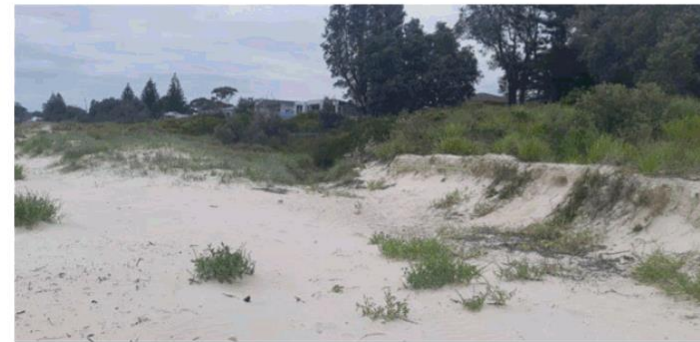
Collingwood Beach – stormwater erosion

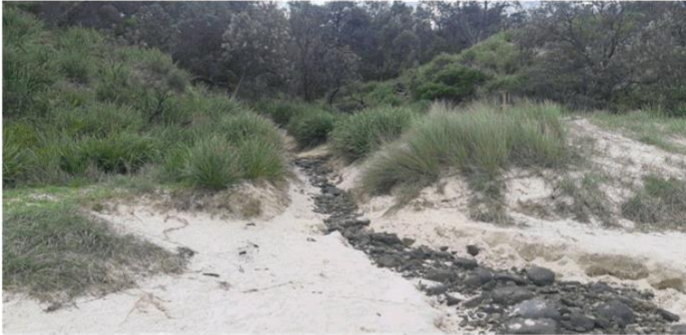
Path eroded by stormwater at Cunjurong Point

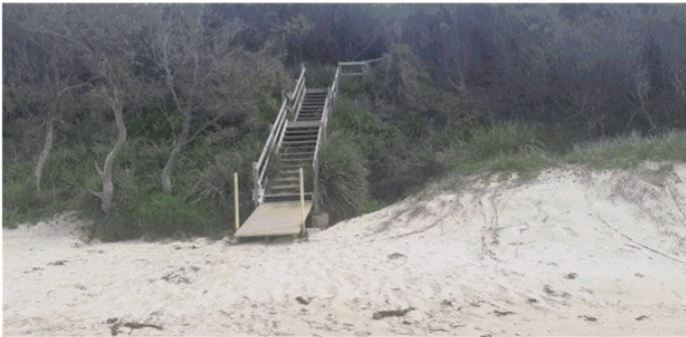
Undermined stairway affected by slope instability at Cunjurong Point

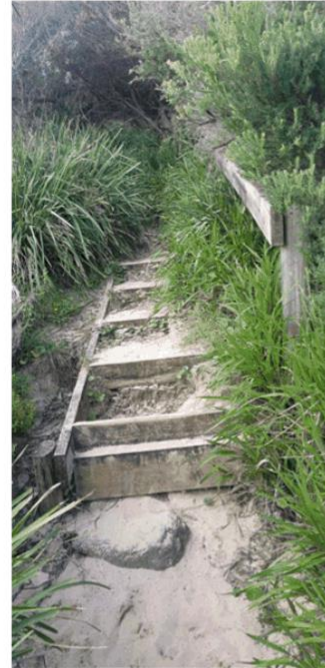
Damaged and overgrown stairway at Bendalong

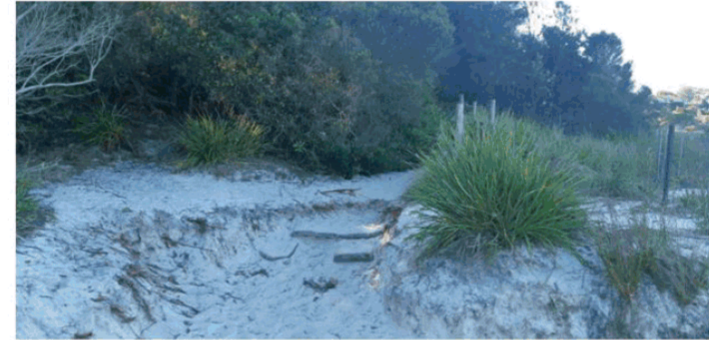
Figure 5-1 – Erosion at base of track (Hyams Beach). Consider reorienting track so it doesn't face south and is more perpendicular to the beach, and consider installation of timber sleepers at base to reduce the effects of this erosion.

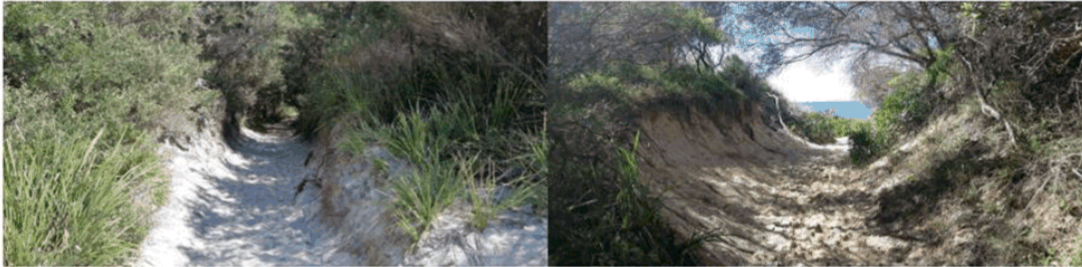
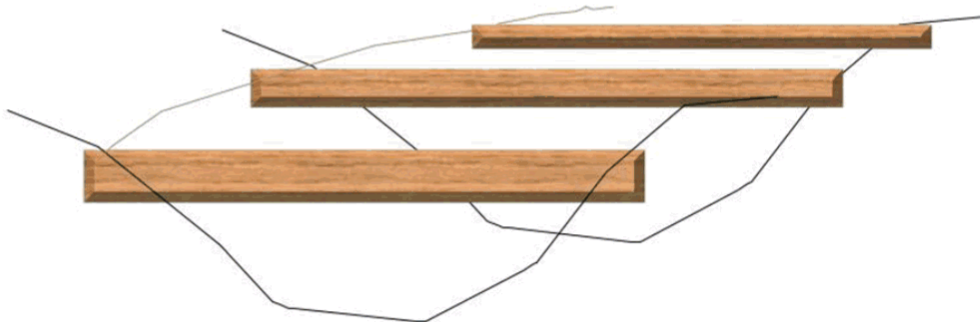
Figure 5-5 – Fill eroded area with sand and install timber sleepers to address lowering of accessway relative to dune

These can be treated by topping up with sand to restore the accessway elevation relative to the dune, and placement of timber sleepers to maintain the accessway level

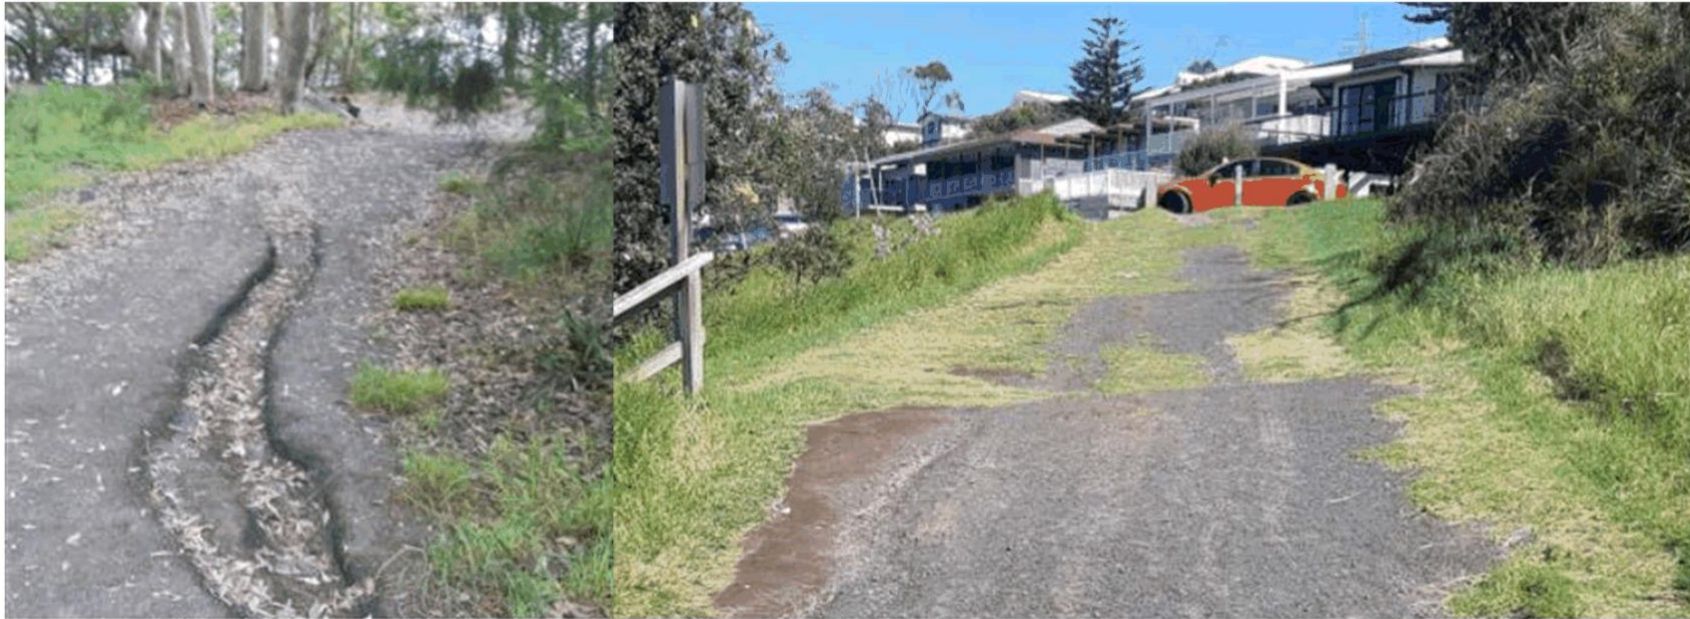
Figure 3-10 – Example of drainage control "hump" in gravel path, Mollymook Beach, March 2021.

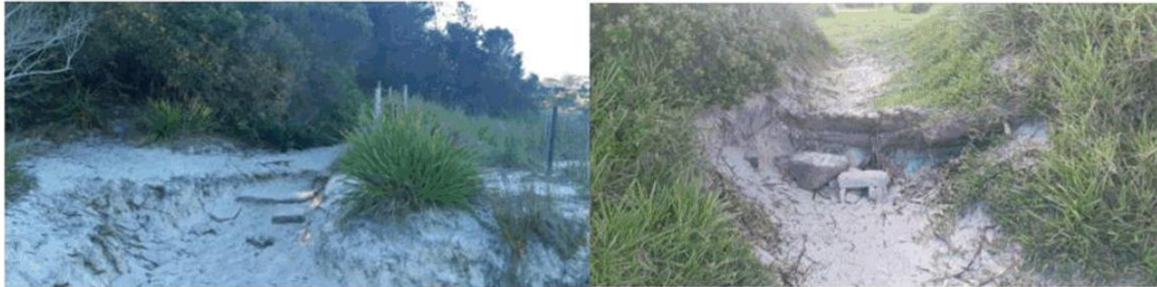
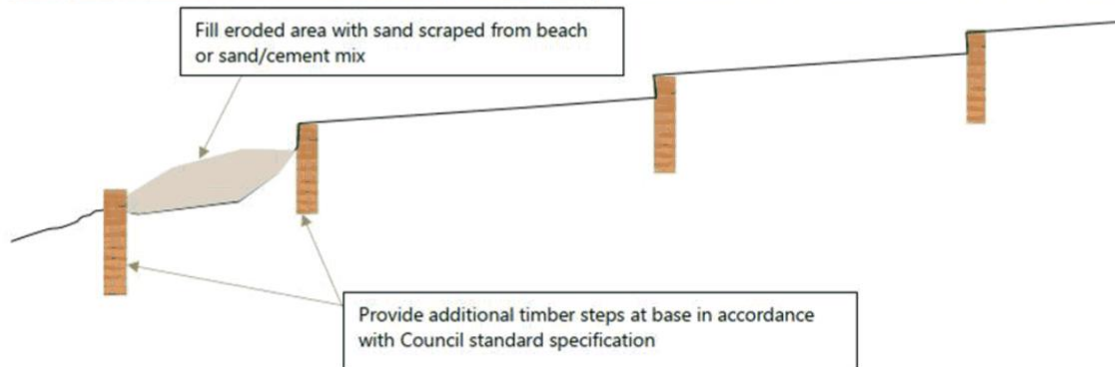
Figure 5-4 – Recommended treatment for erosion at base of access, where gradient is low - moderate (see examples above)

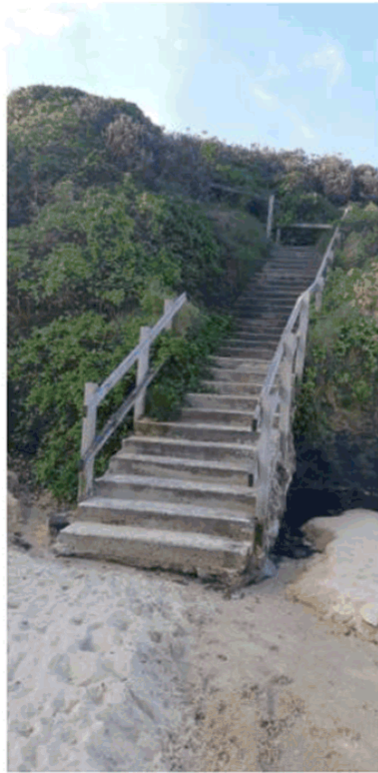
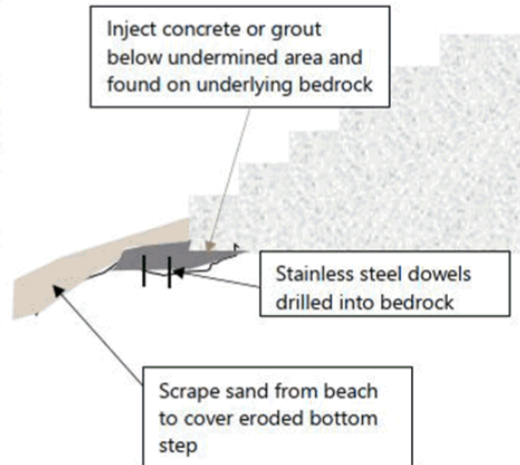
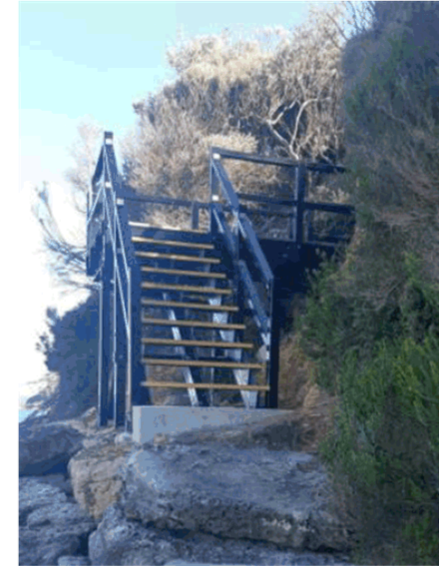
Figure 5-6 – Example undermined staircase and potential treatment

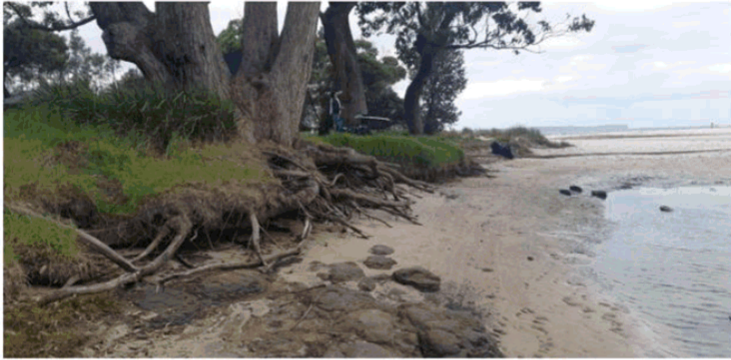
Figure 3-39 – Severe bank erosion at Moona Moona Creek adjacent to timber stairway (February 2021)

- Investigate cause and repair bank erosion
- Consider repairing bank erosion with gravel and placed boulders.

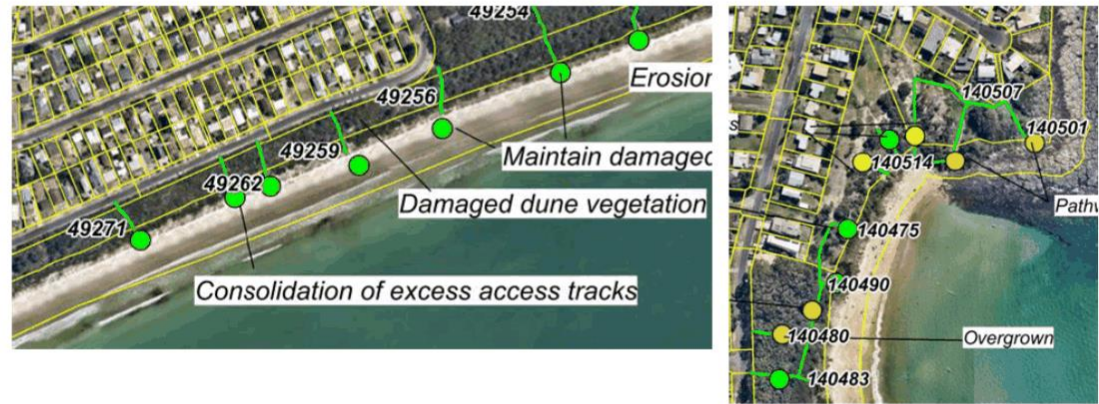
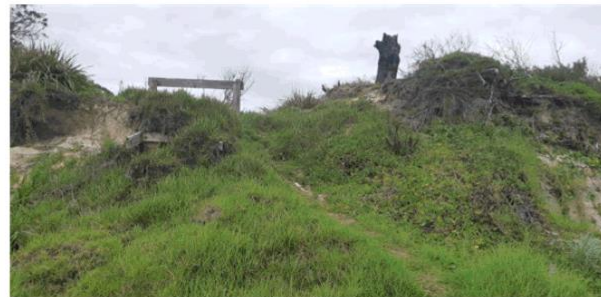
Example – track at Currarong recommended for closure
