Sussex Inlet, St Georges Basin, Swan Lake and Berrara Creek CMP – Stage 2

Coastal Management Committee presentation

4 May 2022

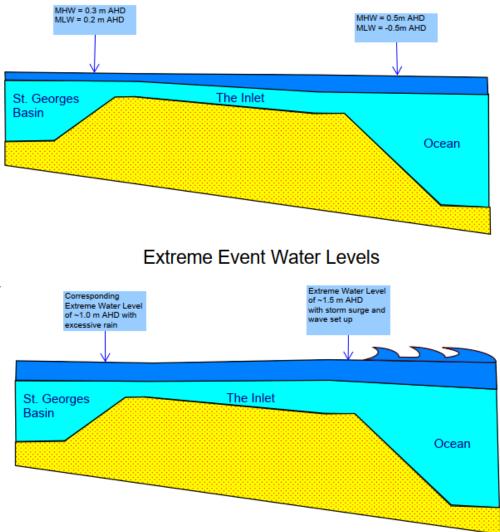
Typical Water Levels

- Tidal inundation refers to inundation of the low-lying land surrounding the waterways that occurs due to oceanic tides
- Can occur independently of rainfall events that cause catchment-based flooding.
- A hydrodynamic model has been developed to quantify the risk

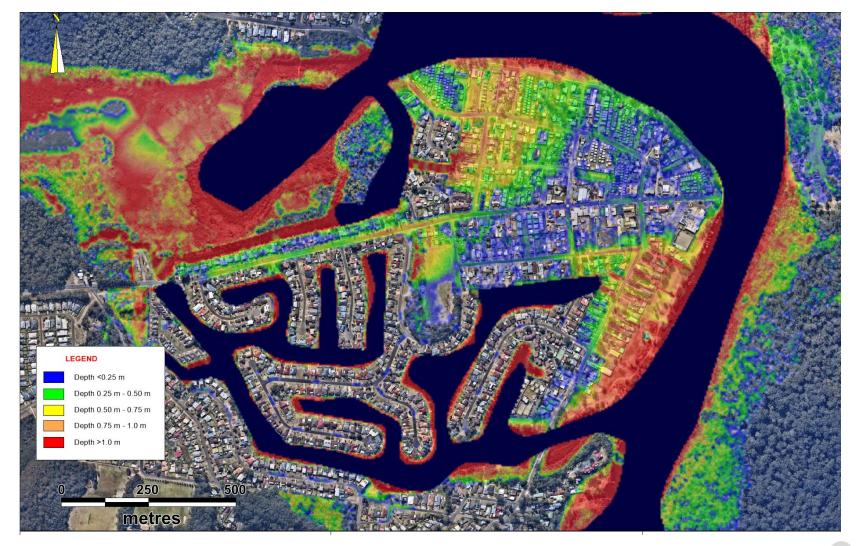
Present Day

(20 year Average Recurrence Interval ARI event)

• Southerly wind 32m/s

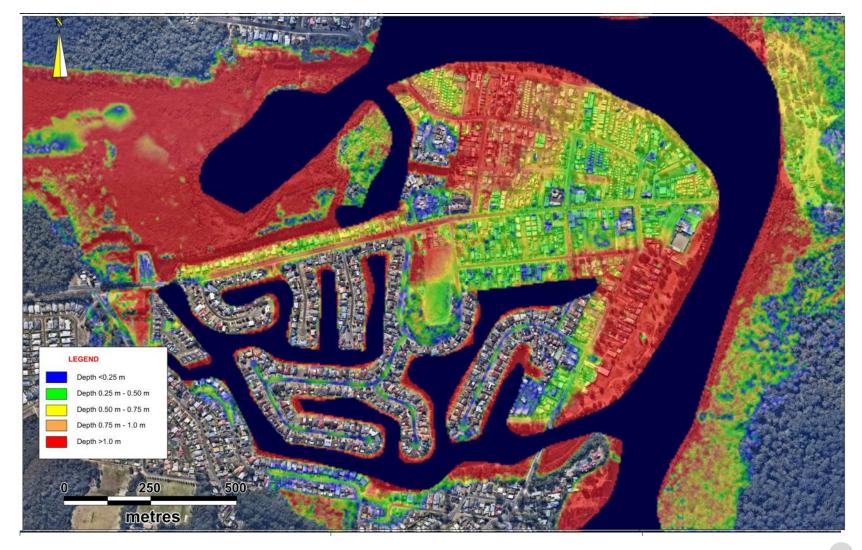
0.36m SLR

(20 year Average Recurrence Interval ARI event, 0.36m SLR)

• Southerly wind 32m/s

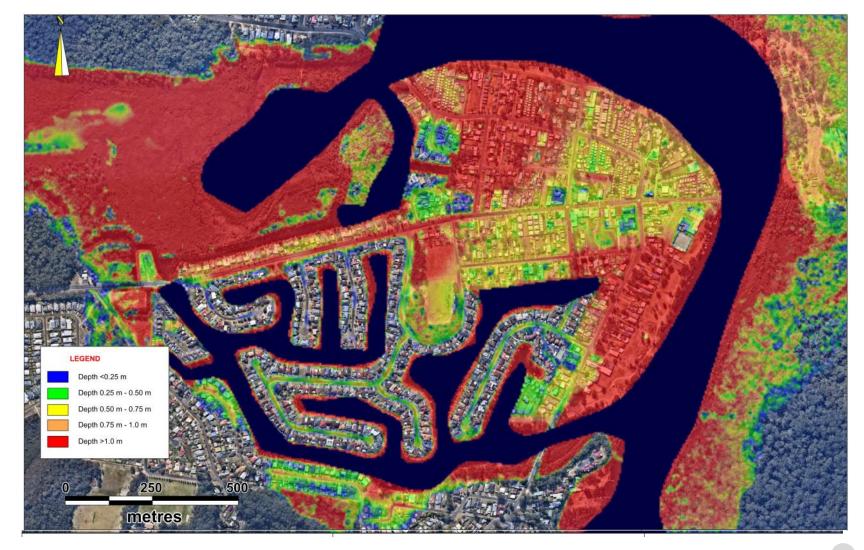
0.6m SLR

(20 year Average Recurrence Interval ARI event, 0.6m SLR)

• Southerly wind 32m/s

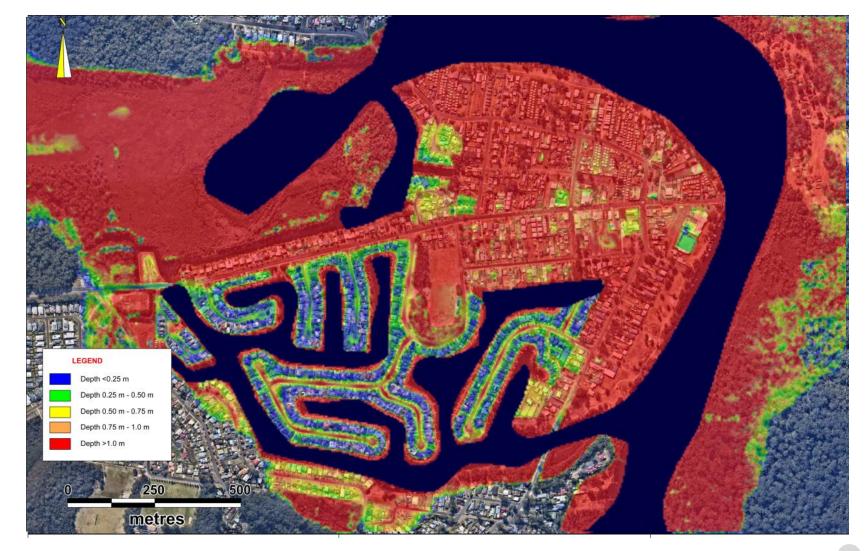
0.9m SLR

(20 year Average Recurrence Interval ARI event, 0.9m SLR)

• Southerly wind 32m/s

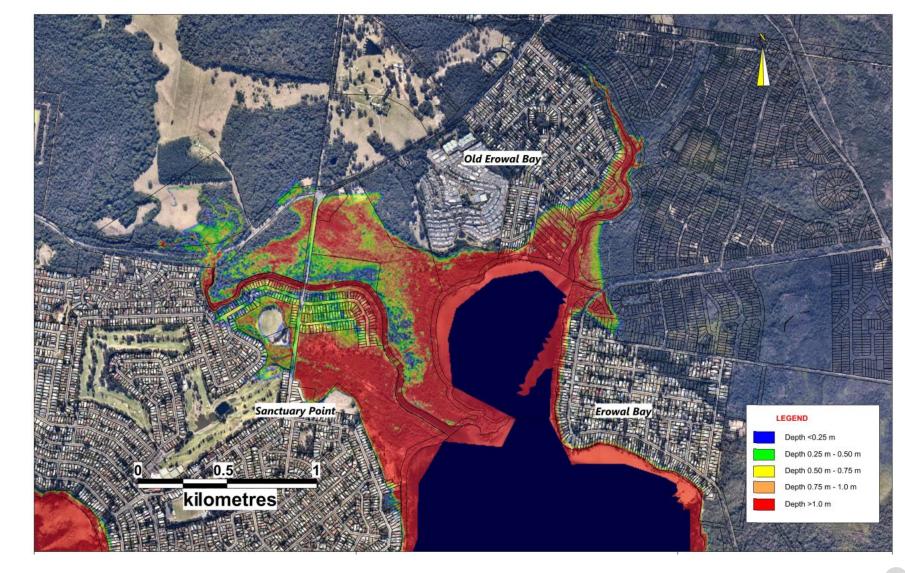
Present Day (20 year ARI event)

Southerly wind 32m/s

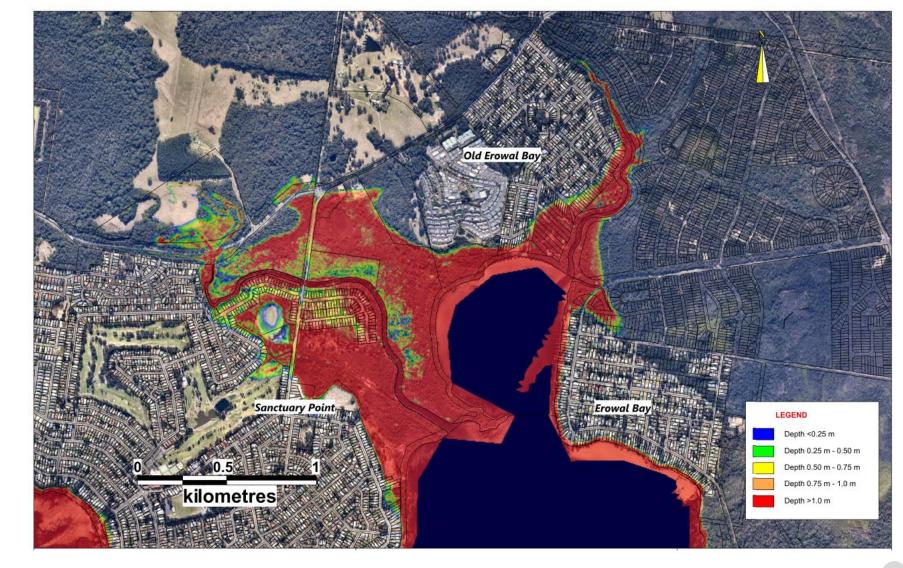
0.36m SLR (20 year ARI event)

Southerly wind 32m/s

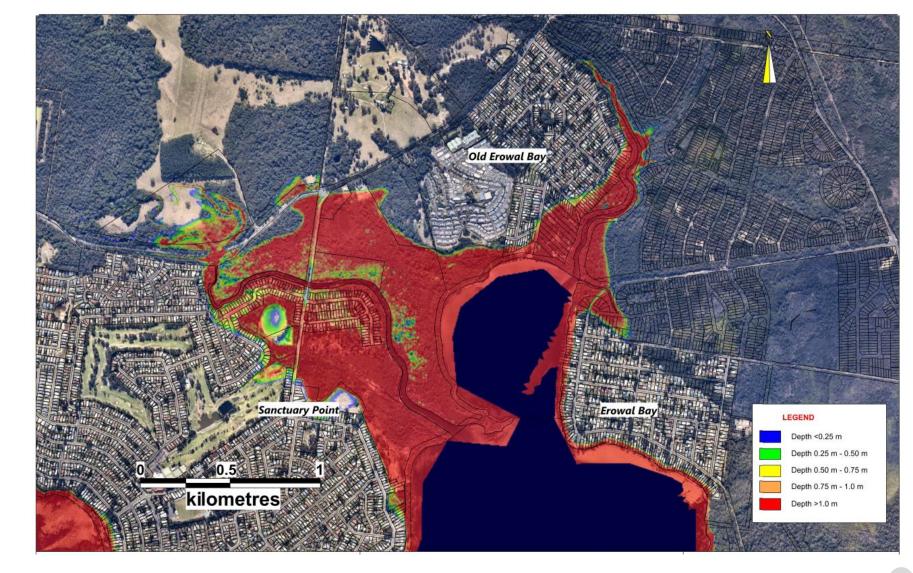
0.6m SLR

(20 year ARI event)

Southerly wind 32m/s

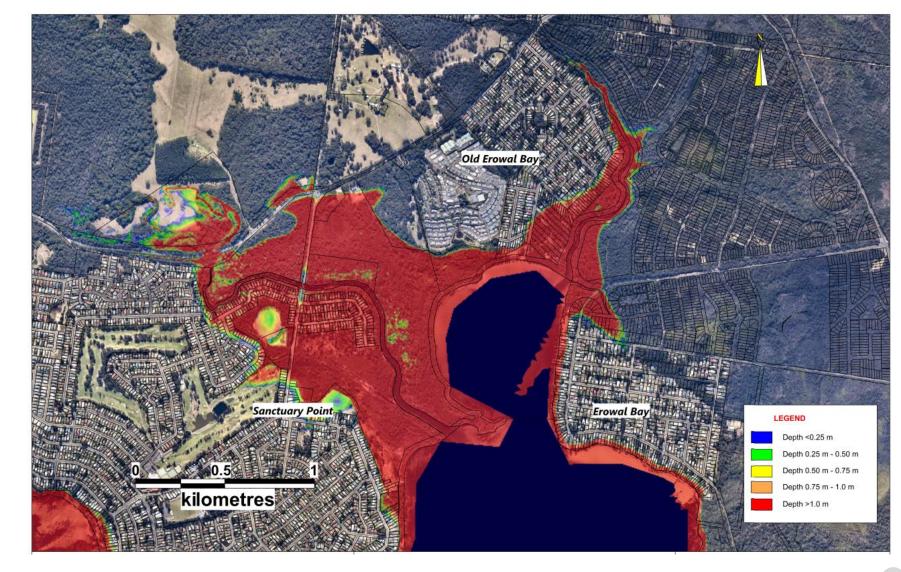
0.9m SLR

(20 year ARI event)

Southerly wind 32m/s

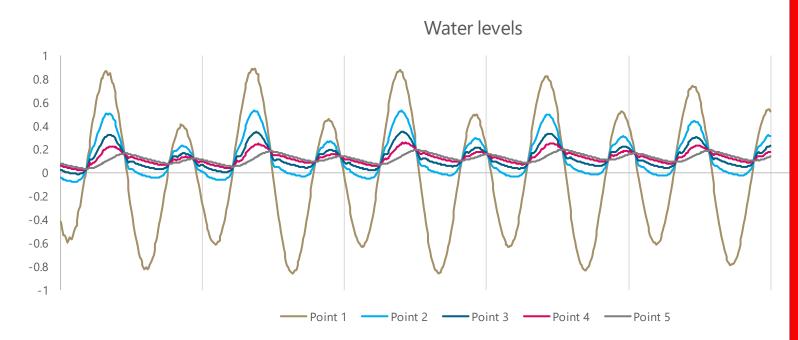
Variation in tidal range with distance upstream

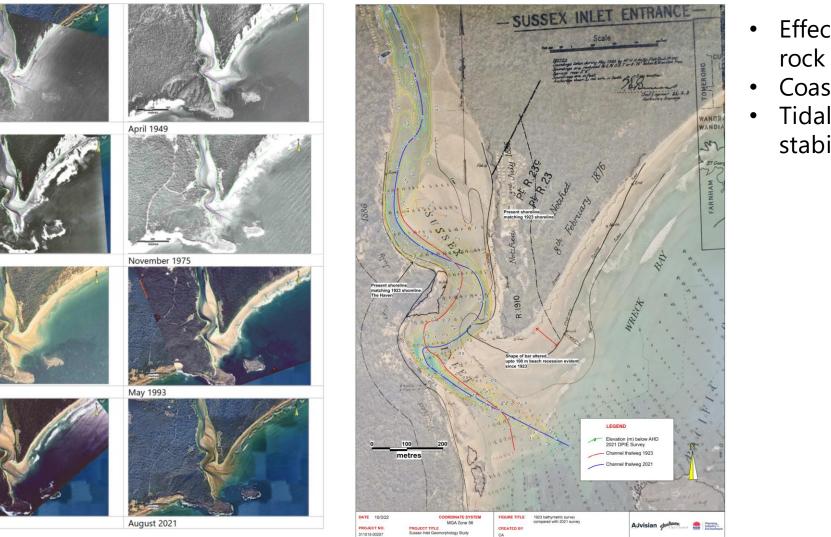
Sussex Inlet Geomorphology Assessment

January 1937

July 1968

June 1981

February 2005

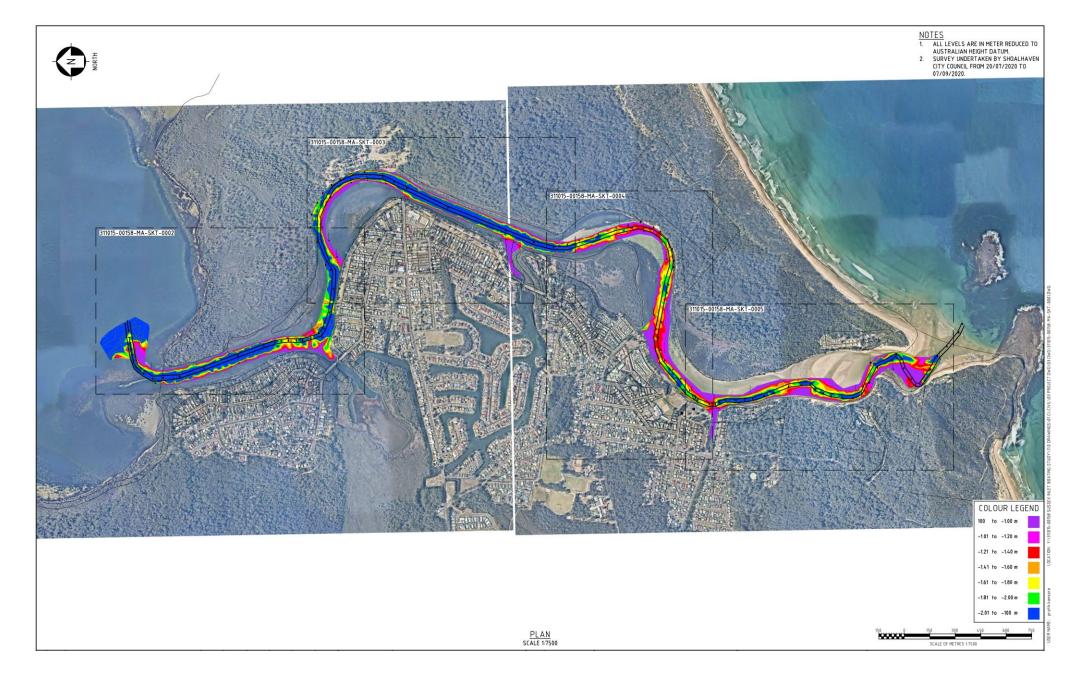
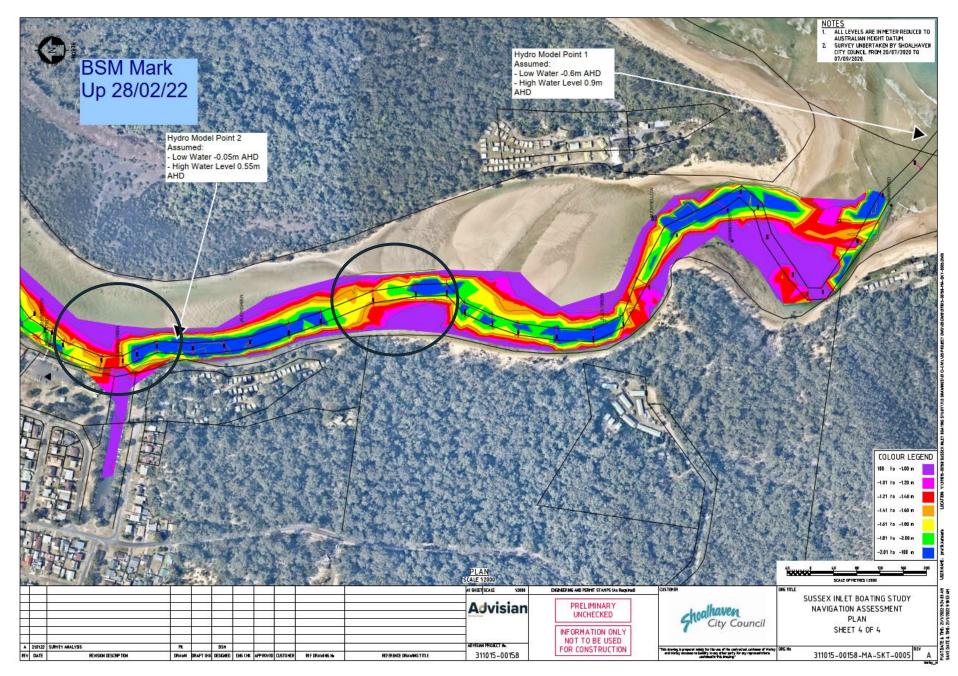
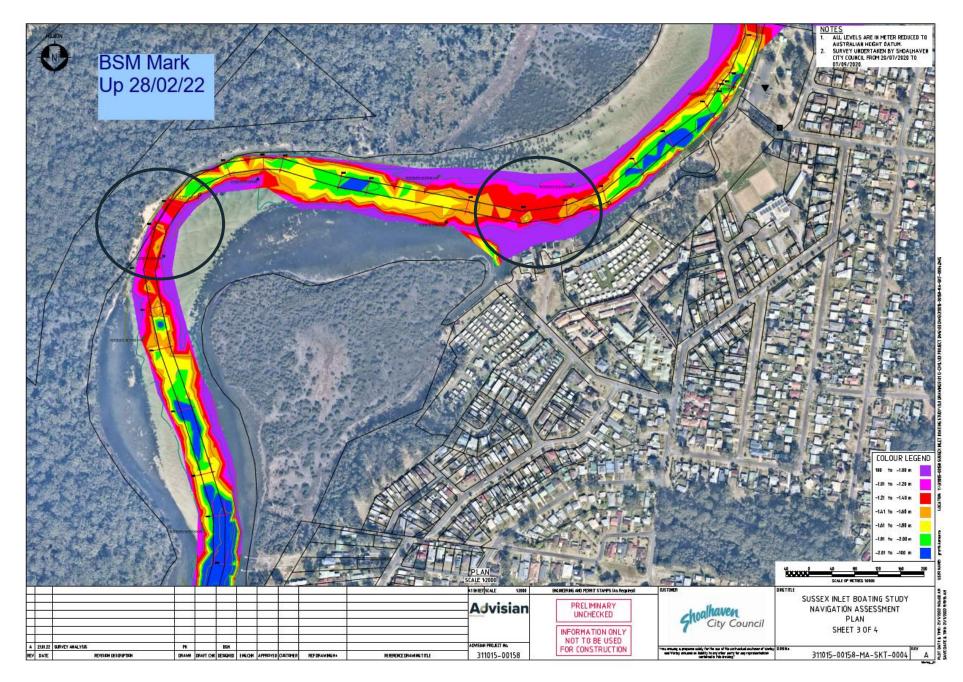
- Effect of historical ballast rock
- Coastal processes
- Tidal inlet dynamics stability of inlet and tidal bar

relict channel

scour through delta during high flow freshwater floods

> westward growth of flood tide delta during low flow conditions

longshore sediment transport westward into entrance area

channel planform controlled by presence of rock

erosive pressure due to westward migration of channel

Onshore-offshore sediment transport driven by swell waves

at long-term equilibrium with scour by tidal currents and floods, and sedimentation through longshore sediment transport

tidal channel maintained

Wave breaking leading to sheltering of entrance area

Relict transgressive dune barrier
