## Central Coastal Management Program Advisory Committee

# Shoalhaven Beaches Asset Management Strategy

October 2021

## Why does Council need a Beach Access Management Strategy?

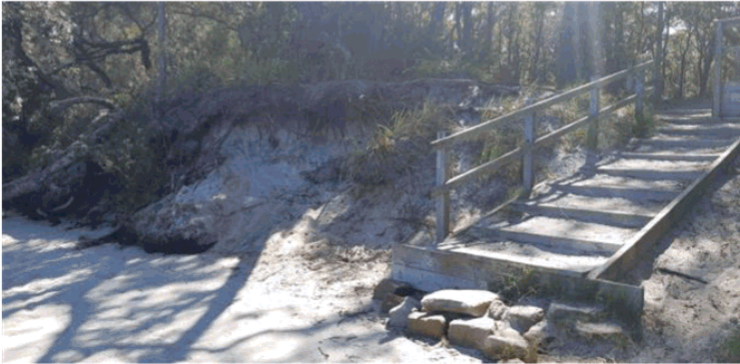
### Moona Moona Creek

Figure 3-39 – Severe bank erosion at Moona Moona Creek adjacent to timber stairway (February 2021)

- Investigate cause and repair bank erosion
- Consider repairing bank erosion with gravel and placed boulders.

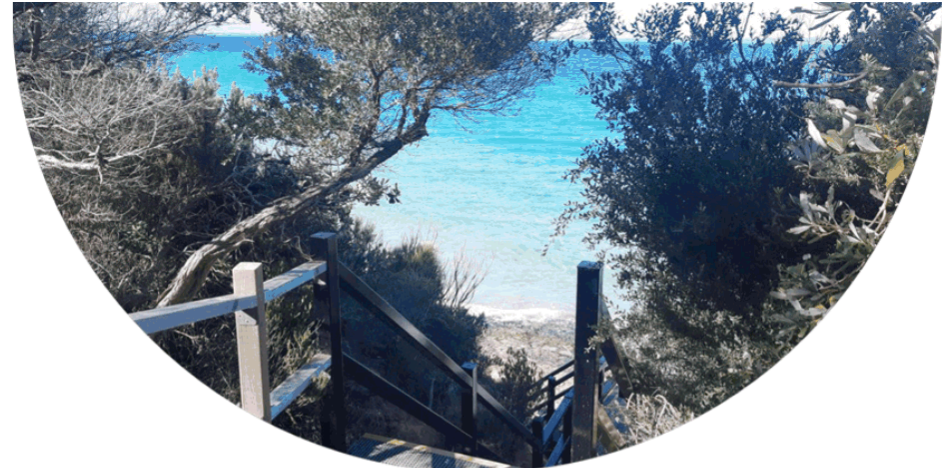
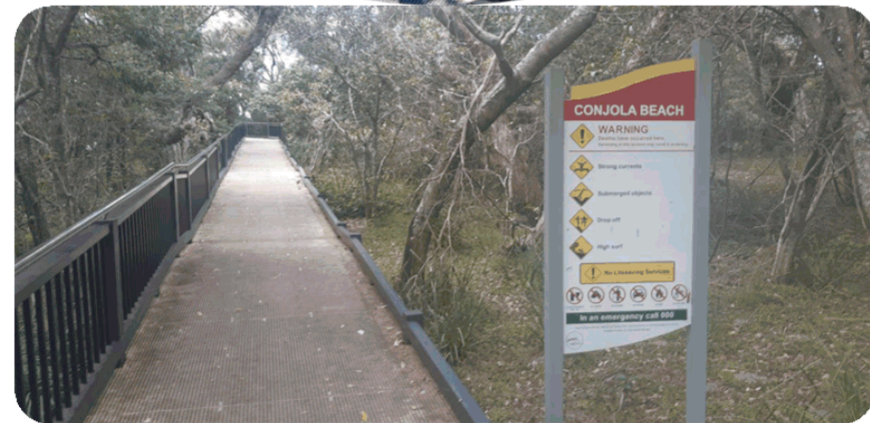
- Why we have recommended some be closed?
- Reduce no. of accessways and focus resources
- Can polarise communities – e.g. backlash from proposed closing of excess accessways at northern end of Callala Beach – need to do best thing for broader community

Example – track at Currarong recommended for closure
